# Tech Tip

FILTERS 148

## FILTER SOLUTIONS For Some Challenging Conditions

### GM'S DURAMAX FUEL FILTERS

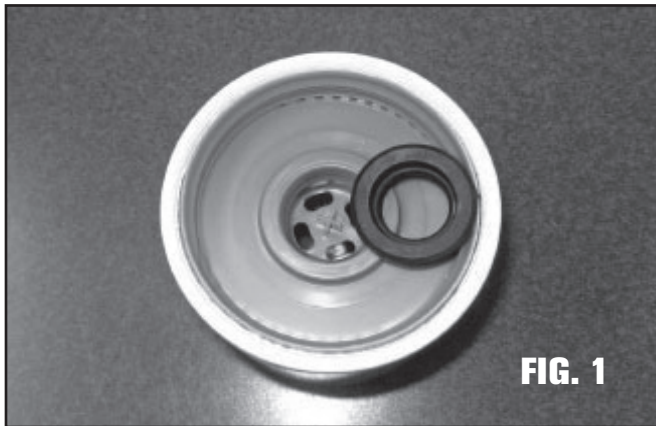
A second condition involves technicians complaining of a difficult fuel filter installation. A frequent complaint is the filter will not thread onto the filter adapter. The installer is usually certain that damaged filter housing threads are the reason for the installation difficulty. The culprit is usually a grommet from the previous filter that is still attached to the filter adapter, making it impossible to install the new filter (see Fig. 1).

Check for detached filter grommet.

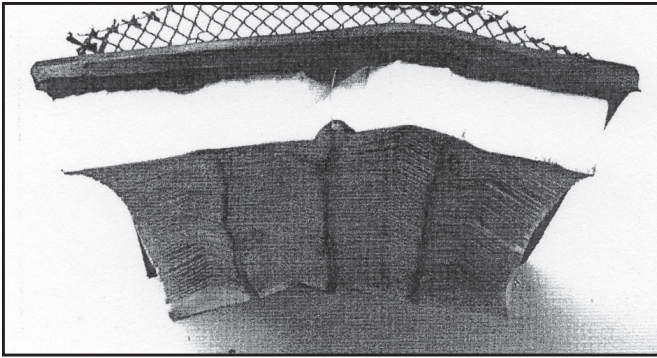
**FIG. 2**

Water and snow are not good air filter companions, especially for turbocharged diesel engines. Either can destroy a lot of expensive parts very quickly. The filter illustrated in Fig. 2 was removed from a Dodge Turbo Diesel that ingested road splash. The water sealed the filter media and the filter was almost pulled from the air box housing. Obviously, the filter lost its seal with the housing, allowing debris to be sucked into the turbocharger and engine. Fortunately, the

filter remained intact and was not shredded, which could have caused major mechanical damage. Snow entry can promote the same scenario. Following are modifications made by Ford and GM to alleviate snow related filter restrictions:

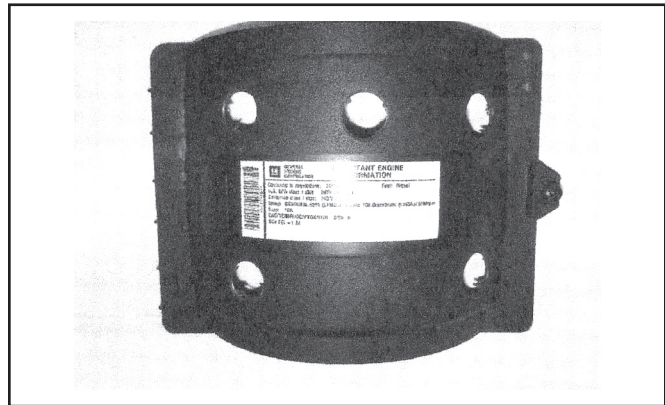
**FIG. 3**

**GM's Duramax...** GM advises that some owners of 2007–2009 Chevrolet Silverado and GMC Sierra 2500/3500 series vehicles may complain of an illuminated Check Engine light with diagnostic trouble code P0101 (mass air flow sensor performance) stored in memory as a history code or current event, and a Reduced Power Message on the DIC. These conditions are the result of snow being ingested into the air cleaner housing and restricting the engine's intake air.

GM recommends purchasing a new air cleaner cover P/N 20821430 and drilling five 25mm holes in the cover as shown in Fig. 3. Install emission label GM P/N 19180225 on the modified cover as shown. Remove the existing air cleaner cover and replace it with the modified cover. Retain the original cover for summer use. A grill opening cover, GM P/N 25822811 for GMC and P/N 25822812 for Chevrolet, should be installed as part of the repair. This modification allows warm air to be circulated into the air cleaner housing, which melts the snow.
