PRODUCT BULLETIN

2017-2018 Chevrolet Colorado / GMC Canyon 3.6L Oil Filter Removal

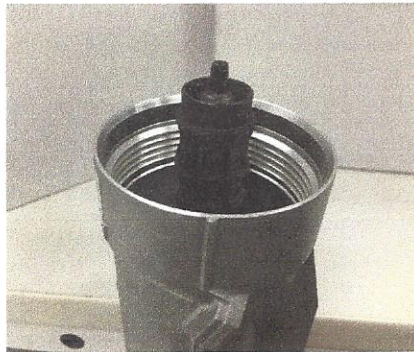
When removing the oil filter on a 2017-2018 Chevrolet Colorado or GMC Canyon equipped with the 3.6L engine, do not remove the standpipe located in the filter housing.

The routing of the A/C hose and other hoses interfere with the removal of the oil filter. Precaution must be taken not to remove the standpipe from the filter housing. It can easily come out with the removal of the filter and go unnoticed if the technician is not observant.

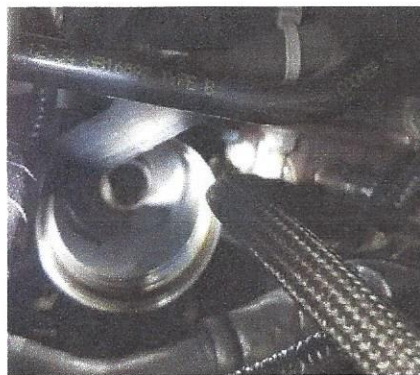
Installing an oil filter without the stand pipe in the housing can result in major engine damage. If removed or broken, the standpipe cannot be replaced. A new filter housing, which is currently on backorder from GM, will have to be purchased and installed.
